**DEPARTMENT OF DEFENCE**  
**DEFENCE SCIENCE AND TECHNOLOGY ORGANISATION**  
**AERONAUTICAL RESEARCH LABORATORIES**  
**MELBOURNE, VICTORIA**

STRUCTURES REPORT 422

CARBON FIBRE COMPOSITE COUPONS -  
STATIC AND FATIGUE BEHAVIOUR AFTER IMPACT DAMAGE

AUGUST 1986

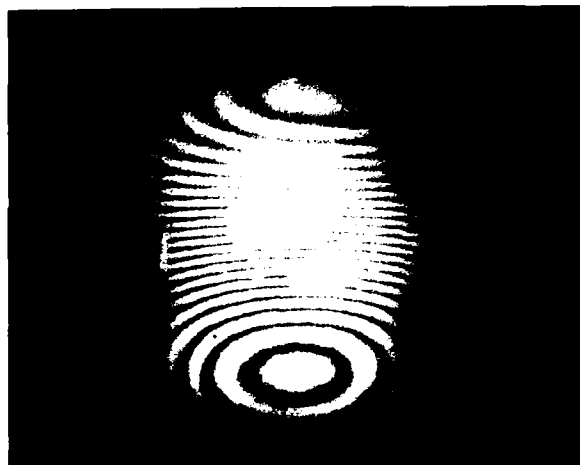
Fig. 13. Shadow Moire representation of the buckling of an inadequately restrained undamaged 24-ply coupon undergoing static compression testing.
